**PHASE I ENVIRONMENTAL  
SITE ASSESSMENT**

**SKYSERVICE AIRLINES INC.  
HANGAR 6 AND 6A  
LESTER B PEARSON  
INTERNATIONAL AIRPORT  
6932 VANGUARD DRIVE  
MISSISSAUGA, ONTARIO**

July 2007  
Reference No. 07-0122

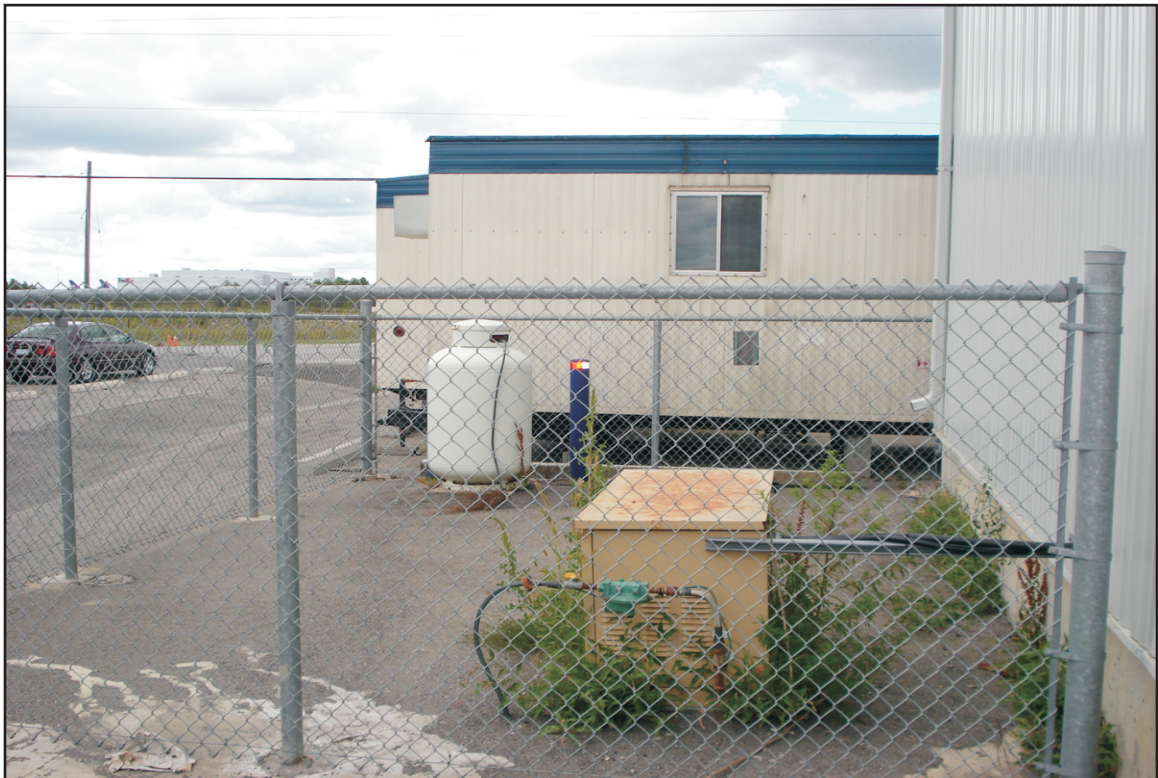
Photograph 2: View of the Propane-fired emergency generator and propane tank looking west.

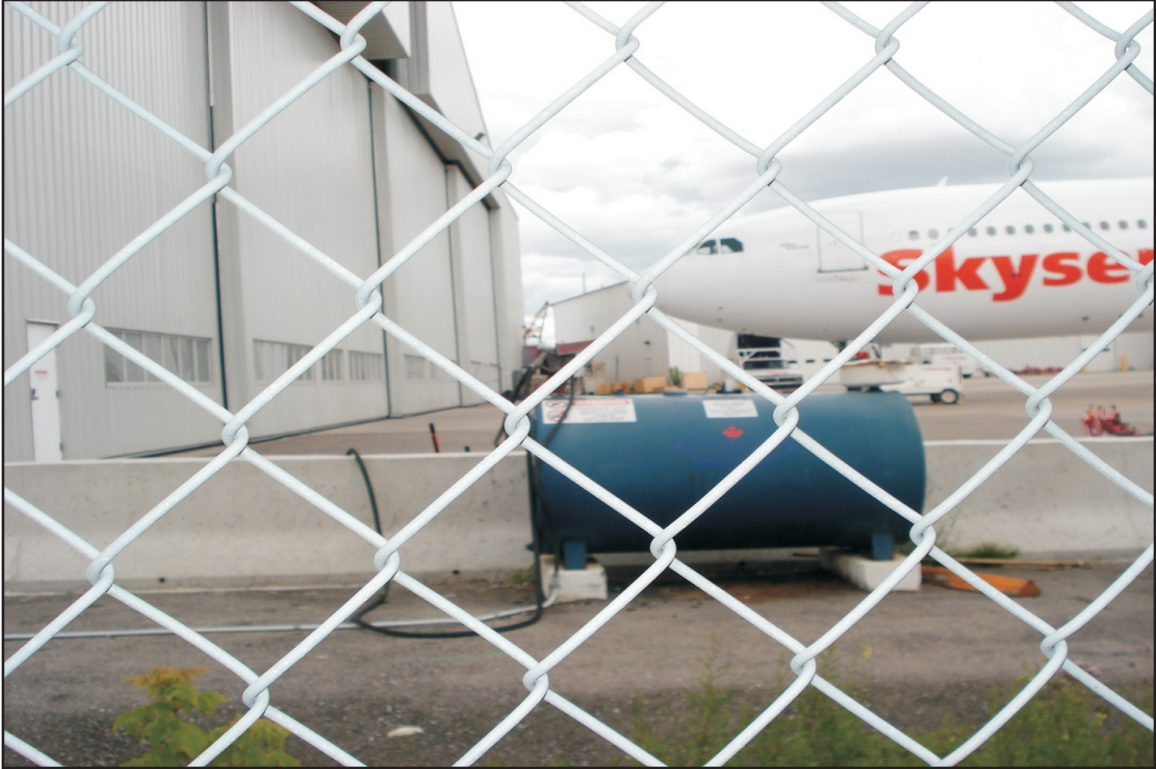
Watters Environmental observed a 500-gallon steel AST east of Hangar 6A (Photograph 3). At the time of the Site reconnaissance, the AST was equipped with fuel dispensing equipment, and was placed on an asphalt paved surface surrounded by concrete curbs. The Site representatives informed Watters Environmental that the AST was installed in approximately 2001, and is used for fuelling aircraft heaters. Watters Environmental did not observe any staining or evidence of leakage on the asphalt-paved surface in the vicinity of the AST. The asphalt-paved area in the vicinity of the AST appeared to be in good condition (i.e., no major cracking or heaving).

- A 500-gallon diesel AST located adjacent to the east of Hangar 6A. Watters Environmental did not observe any significant staining on the asphalt-paved surface within the vicinity of the AST;
- Three, 45-gallon drums of waste oil placed on spill tray located at the southeast corner of Hangar 6A (Photograph 4). Although Watters Environmental observed minor oil staining on the finished concrete floor in the vicinity of these drums, the finished concrete floor was in good condition (i.e., no pitting or cracking);
- One, solvent sink (i.e., parts washers), likely containing petroleum distillate solvents, located on the finished concrete floor at the south end of Hangar 6A; and
- Several metal storage cabinets for storage of new products used for aircraft maintenance such as oil, lubricants, paint and varsol located in Hangar 6 and 6A.

Photograph 3: View of an approximately 500-gallon diesel AST, looking north

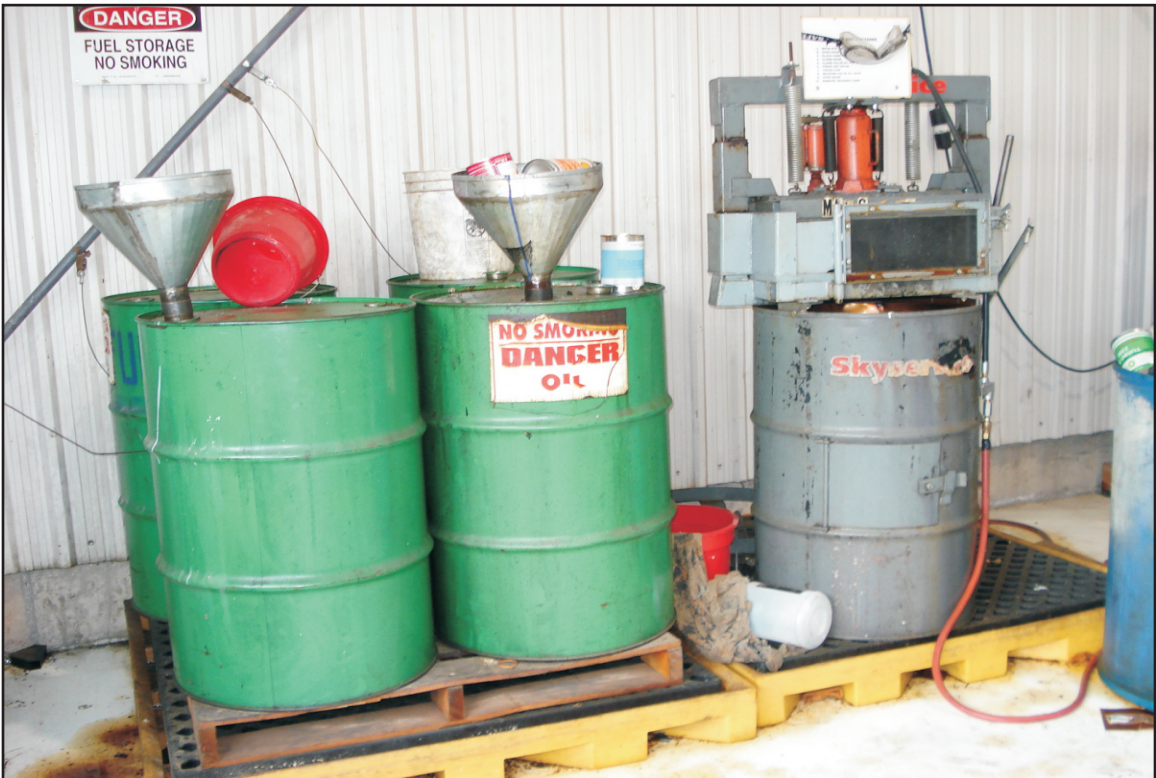
Photograph 4: View of 45-gallon drums for waste oil storage at the southeast corner of Hangar 6A.

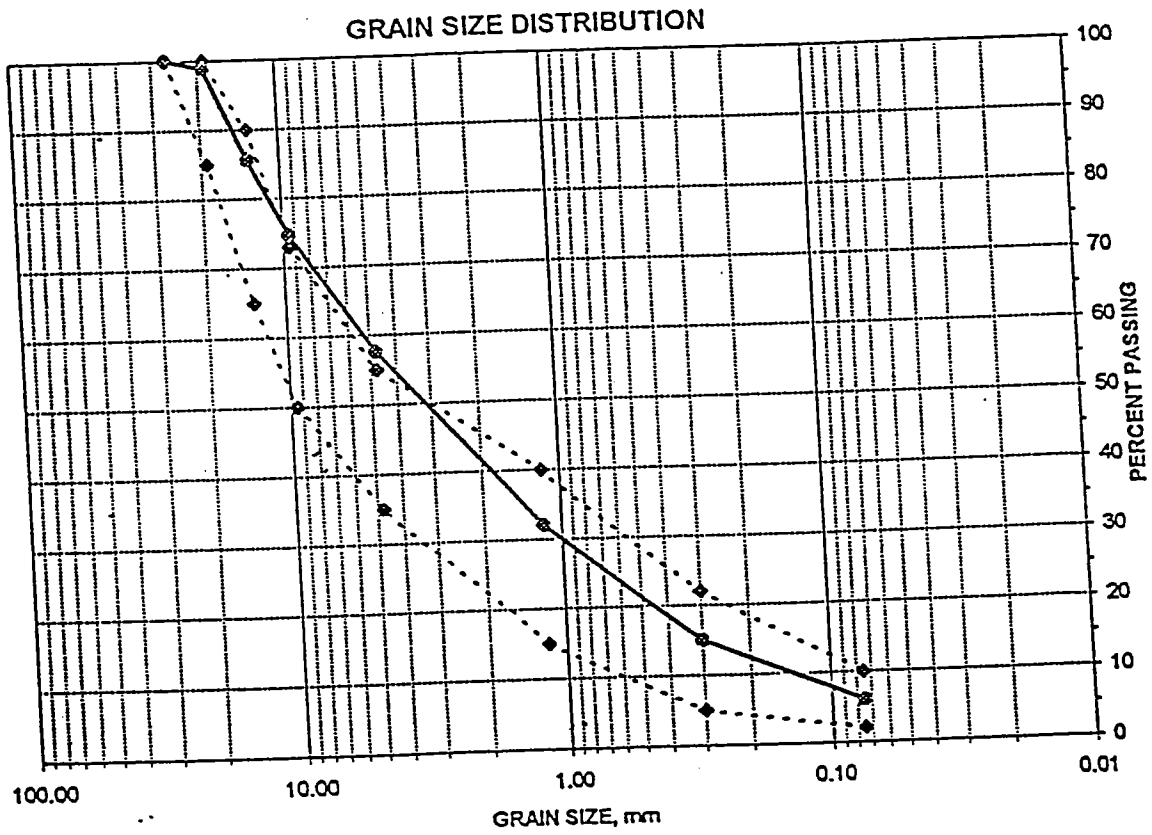
Figure 3 F

SAMPLE MATERIAL: Gran. 'A'  
SAMPLE SOURCE : Borehole 16

SIEVE SIZE mm	PERCENT PASSING		SAMPLE	GRANULAR 'A' OPSS FORM 1010 MARCH 1994
	SPECIFIED MIN.	MAX.		
26.5	100	100	100	NOTES:  Location:  * Denotes not meeting specifications ** Where the aggregate is from a Quarry or slag source
19.0	85	100	99	
13.2	65	90	86	
9.5	50	73	75*	
4.75	35	55	58*	
1.18	15	40	32	
0.300	5	22	15	
0.075	2	10	6

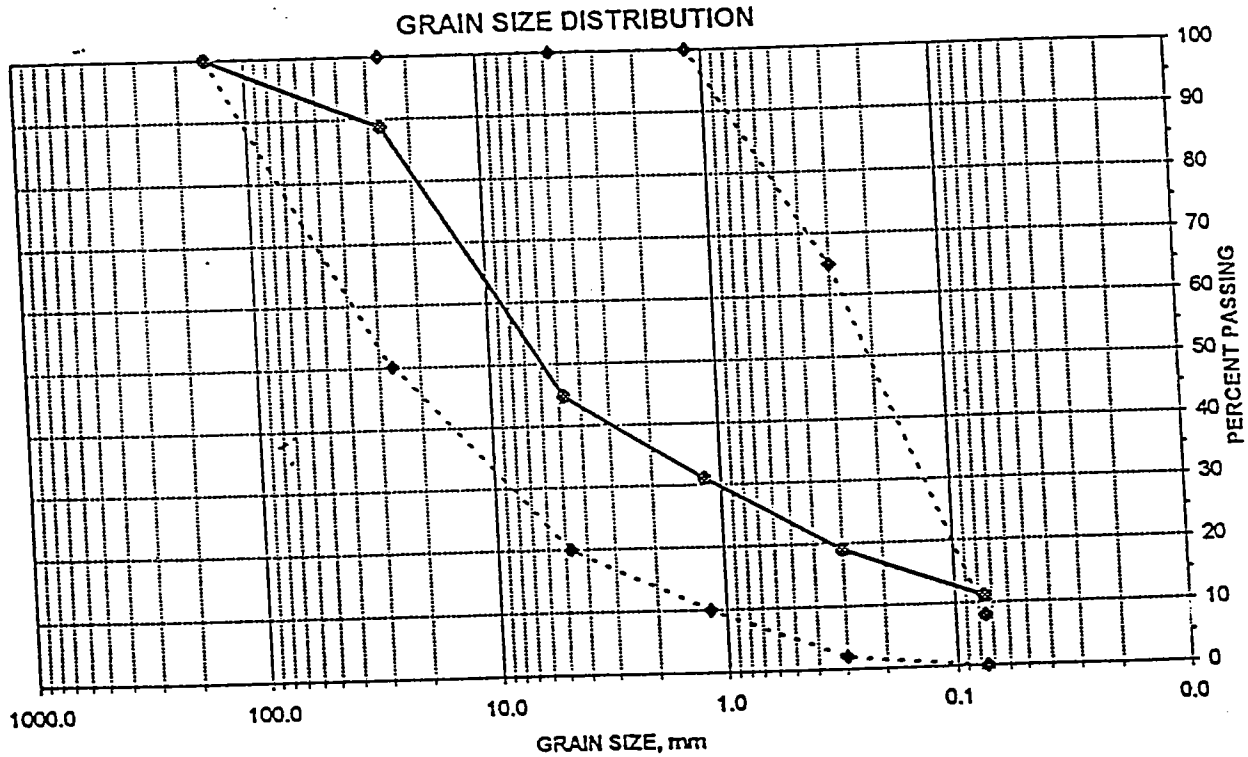
Figure 3 H

SAMPLE MATERIAL: Gran. 'B'  
SAMPLE SOURCE: Borehole 16

SIEVE SIZE mm	PERCENT PASSING		SAMPLE	GRANULAR 'B' OPSS TYPE 1
	MIN.	MAX.		
150.0	100	100	100	NOTES:  *denotes not meeting specifications
26.5	50	100	89	
4.75	20	100	45	
1.180	10	100	31	
0.300	2	65	19	
0.075	0	8	11*
